Manhole Inspection Summary

Manhole # S23M__011MH

Insp Date: **6/19/08 3:00 PM**

Location Address: **1615 Ramsey St**

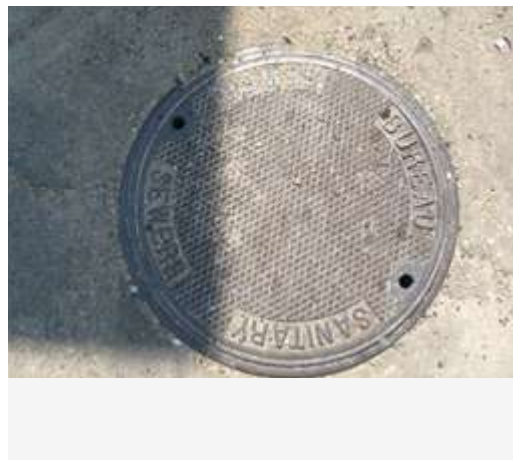
MH Cover

Condition: **Sound**

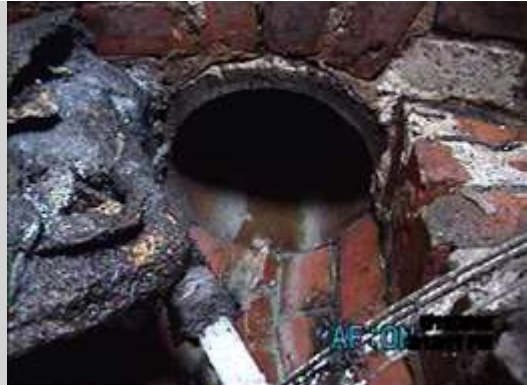
12 O'Clock Outflow

8 in. Circular Gravity Sewer
Pipe Out @ 12 O'Clock

Pipe Height: **9.6** (in.) Rod and Bar (Angled)
Pipe Material: **Clay** ☐ Pipe Lined
Invert Depth: **7.66** (ft.) Flow Characteristics: **Slow**
Deposits: ☒ None ☐ Mud ☐ Gravy ☐ Debris ☐ Grease
Silt Depth: **0** (in.) Deposits Extent:
Infiltration: **None** Pipe Seal Cond: **Sound**

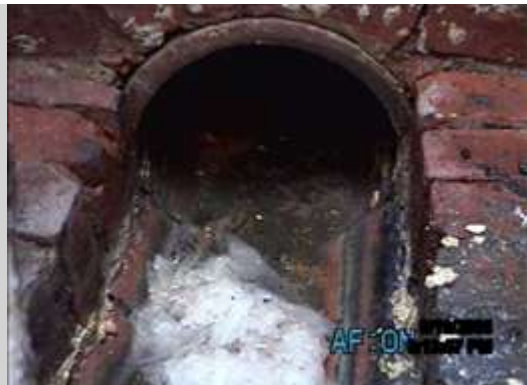
3 O'Clock Inflow

8 in. Circular Gravity Sewer
Pipe In @ 3 O'Clock

Pipe Height: **8.4** (in.) Rod and Bar (Angled)
Pipe Material: **Clay** ☐ Pipe Lined
Invert Depth: **7.60** (ft.) Flow Characteristics: **None**
Deposits: ☒ None ☐ Mud ☐ Gravy ☐ Debris ☐ Grease
Silt Depth: **0** (in.) Deposits Extent:
Infiltration: **None** Pipe Seal Cond: **Sound**
